# Access Compliance Report Public Rights-of-Way (Curb Ramps)

Main Street: ROLLING RIDGE Cross Street: PINEHURST\_ST Location: SW

ADA ID: RPRK211019135406 Ramp Type: Type 4 - Parallel Initial Pass/Fail: Fail Overall Compliance: No Severity Score: 30

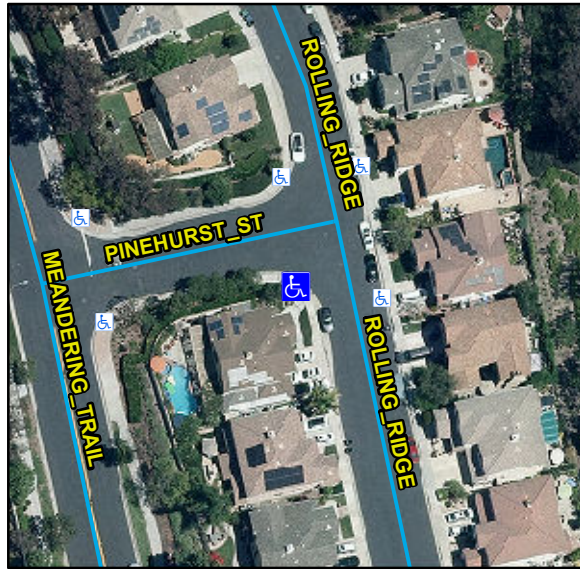
| Compliance | Description | Data | Compliance | Description | Data |
|---|---|---|---|---|---|
| No | Ramp Cross Slope LT (%) | 11.6 | No | Ramp Cross Slope RT (%) | 10.3 |
| No | Gutter Lip Height (in) | 0.25 | | Road Run Slope (%) | 0.5 |

Remove & Replace Curb Ramp With Two New Directional Ramps or Equivalent.

R304.2.2, R204.3, R304.5.3, R302.7.2, STD 1115

Total Cost: \$ 4000
