# Access Compliance Report Public Rights-of-Way (Curb Ramps)

| Main Street: PINEHURST_ST | | Cross Street: ROLLING_RIDGE | | Location: | NW |
| ADA ID: RPRK211019135629 | Ramp Type: Type 4 - Parallel | Initial Pass/Fail: Fail | Overall Compliance: No | Severity Score: | 30 |

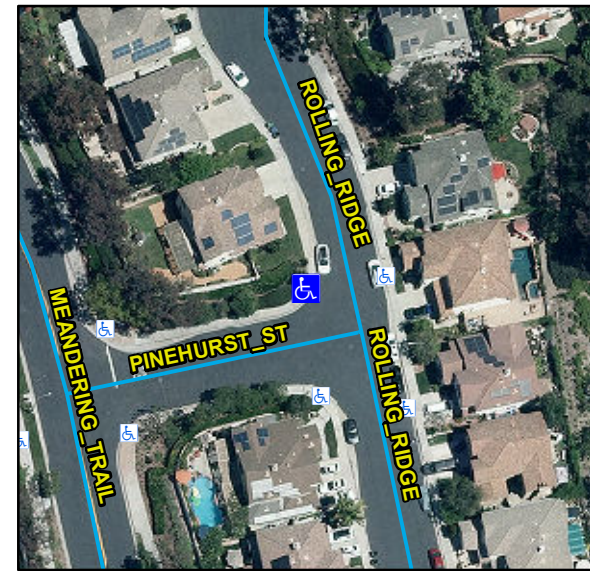
| Compliance | Description | Data | Compliance | Description | Data |
|---|---|---|---|---|---|
| Yes | Ramp Run Slope LT (%) | 3.9 | Yes | Ramp Run Slope RT (%) | 7.7 |
| No | Ramp Cross Slope LT (%) | 11.3 | No | Ramp Cross Slope RT (%) | 12.5 |

**Remove & Replace Curb Ramp With Two New Directional Ramps or Equivalent.**

**R204.3, R304.5.3, STD 1115**

Total Cost: \$ 4000
