# Access Compliance Report Public Rights-of-Way (Curb Ramps)

Main Street: SPRING\_VIEW\_WAY Cross Street: ELM\_PL Location: NE

ADA ID: RPRK211019140300 Ramp Type: Type 4 - Parallel Initial Pass/Fail: Fail Overall Compliance: No Severity Score: 30

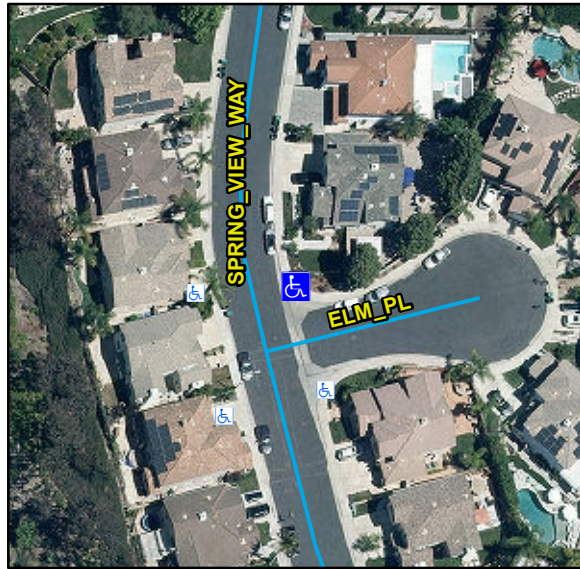
| Compliance | Description | Data | Compliance | Description | Data |
|---|---|---|---|---|---|
| Yes | Ramp Run Slope LT (%) | 2.1 | Yes | Ramp Run Slope RT (%) | 7.1 |
| No | Ramp Cross Slope LT (%) | 12.7 | No | Ramp Cross Slope RT (%) | 13 |

**Remove & Replace Curb Ramp With Two New Directional Ramps or Equivalent.**

**R204.3, R304.5.3, STD 1115**
