# Access Compliance Report Public Rights-of-Way (Curb Ramps)

Main Street: ELM\_PL Cross Street: SPRING\_VIEW\_WAY Location: SE

ADA ID: RPRK211019140504 Ramp Type: Type 4 - Parallel Initial Pass/Fail: Fail Overall Compliance: No Severity Score: 30

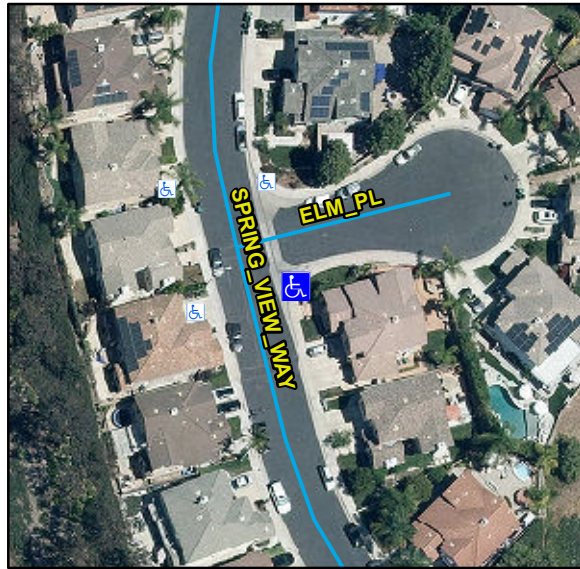
| Compliance | Description | Data | Compliance | Description | Data |
|---|---|---|---|---|---|
| No | Ramp Cross Slope LT (%) | 8.9 | No | Ramp Cross Slope RT (%) | 10.7 |
| N/A | Gutter Ponding | N/A | No | Curb Slope | 14 |
| N/A | Gutter Cross Slope (%) | N/A | No | Perpendicular Joint Present | No |

**Remove & Replace Curb Ramp With Two New Directional Ramps or Equivalent.**

**R304.2.2, R204.3, R304.5.3, STD 1115**

Total Cost: \$ 4000
