# Access Compliance Report Public Rights-of-Way (Curb Ramps)

| Main Street: SPRING_VIEW_WAY | Cross Street: ROLLING_RIDGE | Location: SE |

| ADA ID: RPRK211019140953 | Ramp Type: Type 4 - Parallel | Initial Pass/Fail: Fail | Overall Compliance: No | Severity Score: 30 |

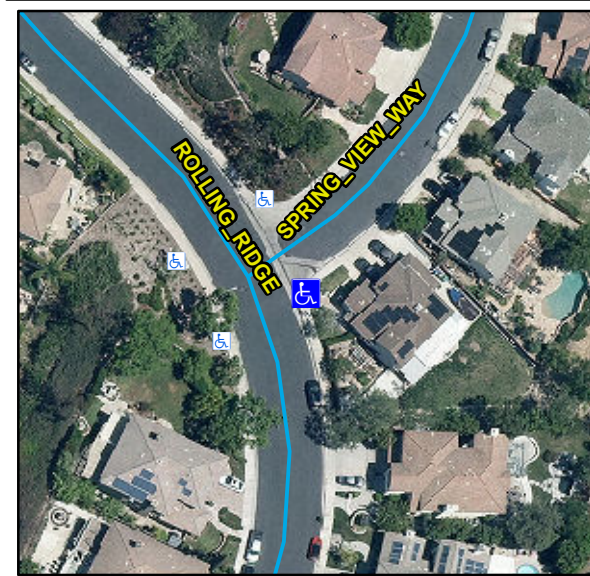
| Compliance | Description | Data | Compliance | Description | Data |
|---|---|---|---|---|---|
| No | Ramp Cross Slope LT (%) | 8.1 | No | Ramp Cross Slope RT (%) | 9.3 |
| No | Gutter Lip Height (in) | 0.25 | | Road Run Slope (%) | 2.9 |

**Remove & Replace Curb Ramp With Two New Directional Ramps or Equivalent. Grind Gutter Lip.**

**R204.3, R304.5.3, R302.7.2, STD 1115**

Total Cost: \$ 4150

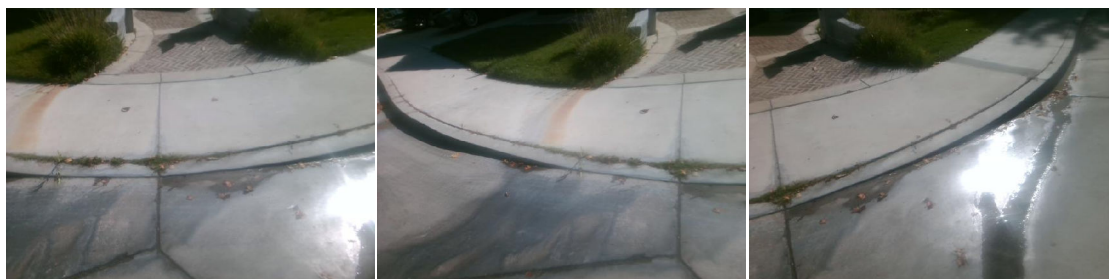
| Compliance | Description | Data | Compliance | Description | Data |
| N/A | Ramp Length LT (in) | 117 | N/A | Ramp Length RT (in) | 117 |
| Yes | Ramp Width LT (in) | 53 | Yes | Ramp Width RT (in) | 54 |
| Yes | Ramp Run Slope LT (%) | 1.3 | Yes | Ramp Run Slope RT (%) | 6.6 |

Possible Solutions:
