# Access Compliance Report Public Rights-of-Way (Curb Ramps)

Main Street: ROLLING RIDGE Cross Street: SPRING VIEW WAY Location: NE

ADA ID: RPRK211019141227 Ramp Type: Type 4 - Parallel Initial Pass/Fail: Fail Overall Compliance: No Severity Score: 45

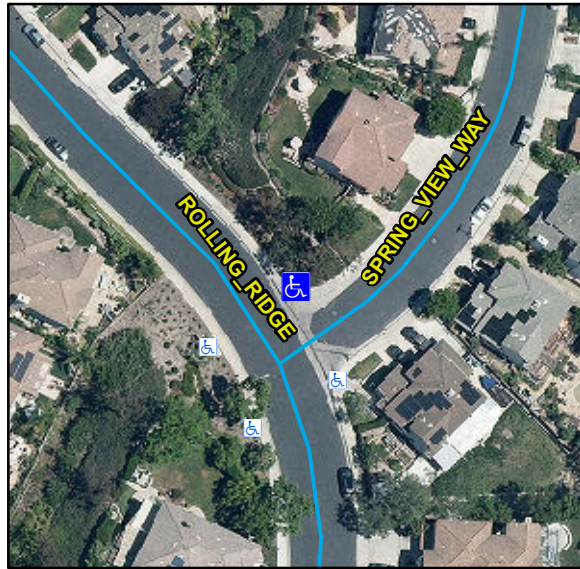
| Compliance | Description | Data | Compliance | Description | Data |
|---|---|---|---|---|---|
| No | Ramp Run Slope LT (%) | 10.2 | No | Ramp Run Slope RT (%) | 11.1 |
| No | Ramp Cross Slope LT (%) | 11.5 | No | Ramp Cross Slope RT (%) | 12.2 |

**Remove & Replace Curb Ramp With Two New Directional Ramps or Equivalent.**

**R204.3, R304.3.2, R304.5.3, STD 1115**

Total Cost: \$ 4000
