# Access Compliance Report Public Rights-of-Way (Curb Ramps)

Main Street: LOST\_CANYON Cross Street: ROLLING\_RIDGE Location: SW

ADA ID: RPRK211019142018 Ramp Type: Type 4 - Parallel Initial Pass/Fail: Fail Overall Compliance: No Severity Score: 60

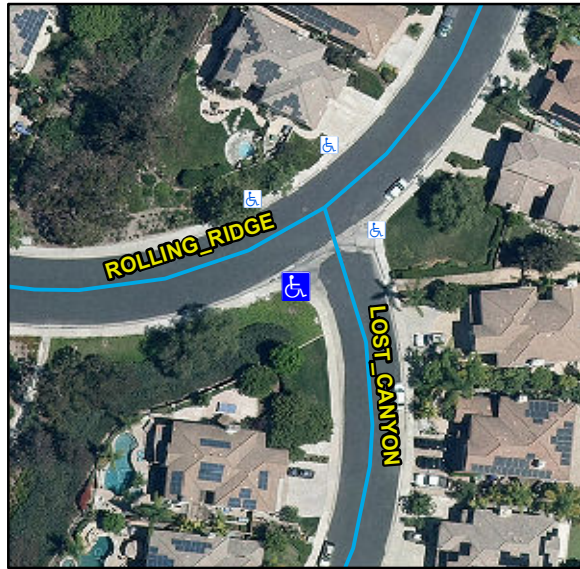
| Compliance | Description | Data | Compliance | Description | Data |
|---|---|---|---|---|---|
| No | Ramp Run Slope LT (%) | 14.1 | Yes | Ramp Run Slope RT (%) | 5.5 |
| No | Ramp Cross Slope LT (%) | 12.2 | No | Ramp Cross Slope RT (%) | 9.7 |

Remove & Replace Curb Ramp With Two New Directional Ramps or Equivalent.

R204.3, R304.3.2, R304.5.3, STD 1115
