# Access Compliance Report Public Rights-of-Way (Curb Ramps)

| Main Street: ROLLING_RIDGE | | Cross Street: SHEA_RIDGE | | Location: | S |
| ADA ID: RPRK211019142246 | Ramp Type: Type 4 - Parallel | Initial Pass/Fail: Fail | Overall Compliance: No | Severity Score: | 45 |

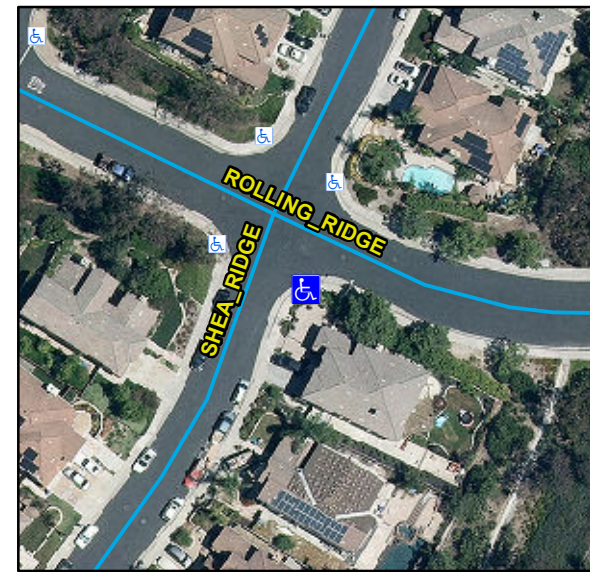
| Compliance | Description | Data | Compliance | Description | Data |
|---|---|---|---|---|---|
| No | Ramp Run Slope LT (%) | 9.1 | No | Ramp Run Slope RT (%) | 8.6 |
| No | Ramp Cross Slope LT (%) | 12.9 | No | Ramp Cross Slope RT (%) | 14.2 |
| No | Gutter Lip Height (in) | 0.25 | | Road Run Slope (%) | 4.6 |

**Remove & Replace Curb Ramp With Two New Directional Ramps or Equivalent. Grind Gutter Lip.**

**R204.3, R304.3.2, R304.5.3, R302.7.2, STD 1115**

Total Cost: \$ 4150

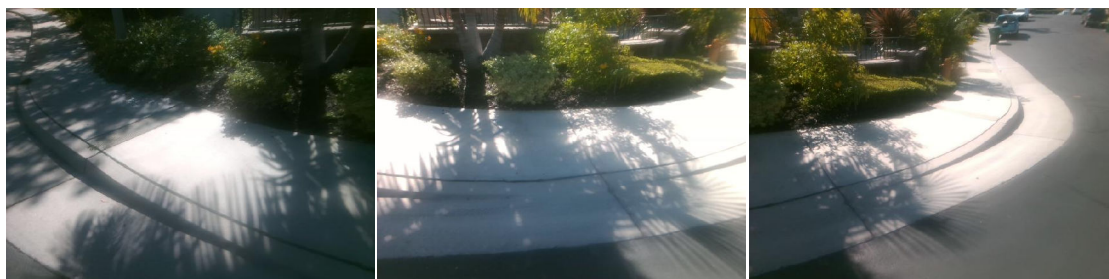
| Compliance | Description | Data | Compliance | Description | Data |
|---|---|---|---|---|---|
| N/A | Ramp Length LT (in) | 119 | N/A | Ramp Length RT (in) | 118 |
| Yes | Ramp Width LT (in) | 54 | Yes | Ramp Width RT (in) | 54 |
