# Access Compliance Report Public Rights-of-Way (Curb Ramps)

Main Street: SHEA\_RIDGE Cross Street: ROLLING\_RIDGE Location: E

ADA ID: RPRK211019142614 Ramp Type: Type 4 - Parallel Initial Pass/Fail: Fail Overall Compliance: No Severity Score: 45

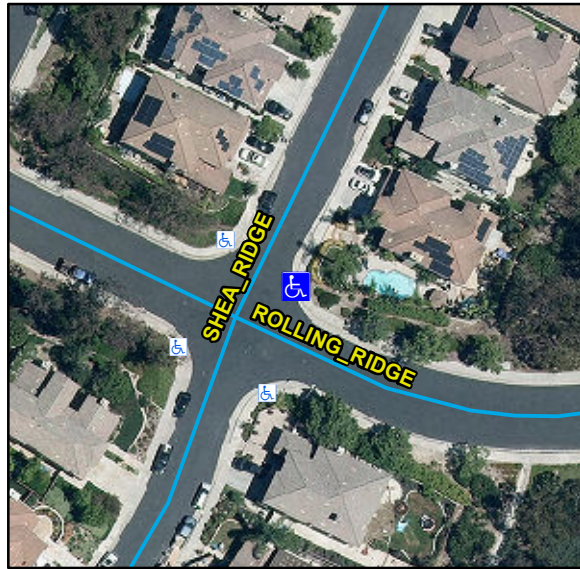
| Compliance | Description | Data | Compliance | Description | Data |
|---|---|---|---|---|---|
| Yes | Ramp Run Slope LT (%) | 5.8 | No | Ramp Run Slope RT (%) | 8.6 |
| No | Ramp Cross Slope LT (%) | 12.6 | No | Ramp Cross Slope RT (%) | 12.7 |

**Remove & Replace Curb Ramp With Two New Directional Ramps or Equivalent.**

**R204.3, R304.5.3, R304.3.2, STD 1115**
