# Access Compliance Report Public Rights-of-Way (Curb Ramps)

Main Street: ROLLING\_RIDGE Cross Street: SHEA\_RIDGE Location: N

ADA ID: RPRK211019142831 Ramp Type: Type 4 - Parallel Initial Pass/Fail: Fail Overall Compliance: No Severity Score: 45

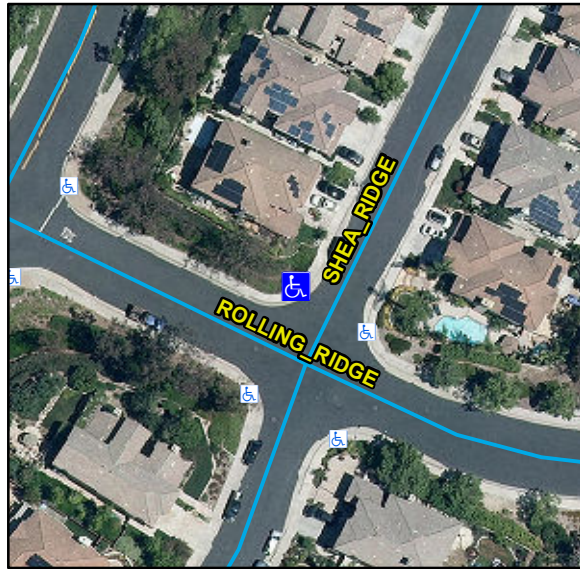
| Compliance | Description | Data | Compliance | Description | Data |
|---|---|---|---|---|---|
| No | Ramp Run Slope LT (%) | 10 | No | Ramp Run Slope RT (%) | 8.4 |
| No | Ramp Cross Slope LT (%) | 12.1 | No | Ramp Cross Slope RT (%) | 13.1 |

**Remove & Replace Curb Ramp With Two New Directional Ramps or Equivalent.**

**R204.3, R304.3.2, R304.5.3, STD 1115**
