# Access Compliance Report Public Rights-of-Way (Curb Ramps)

Main Street: SHEA\_RIDGE Cross Street: ROLLING\_RIDGE Location: W

ADA ID: RPRK211019143046 Ramp Type: Type 4 - Parallel Initial Pass/Fail: Fail Overall Compliance: No Severity Score: 30

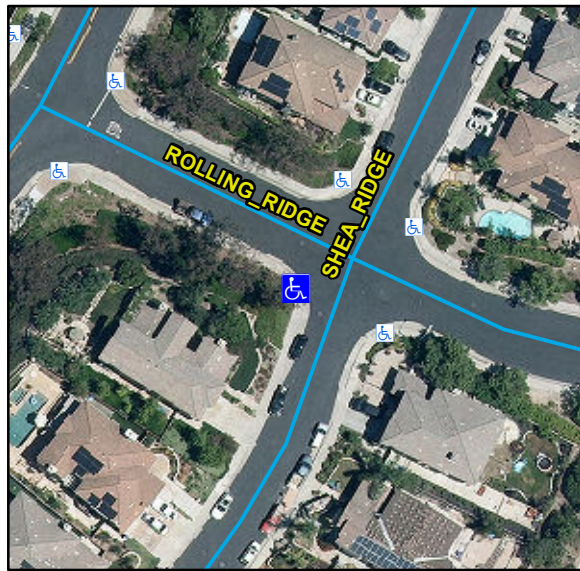
| Compliance | Description | Data | Compliance | Description | Data |
|---|---|---|---|---|---|
| No | Ramp Run Slope LT (%) | 13.5 | Yes | Ramp Run Slope RT (%) | 1.9 |

Remove & Replace Curb Ramp With Two New Directional Ramps or Equivalent.

R304.3.2, STD 1115
