# Access Compliance Report Public Rights-of-Way (Curb Ramps)

Main Street: **ROLLING\_RIDGE** Cross Street: **MEANDERING\_TRAIL** Location: **S**

ADA ID: **RPRK211019143328** Ramp Type: **Type 4 - Parallel** Initial Pass/Fail: **Fail** Overall Compliance: **No** Severity Score: **30**

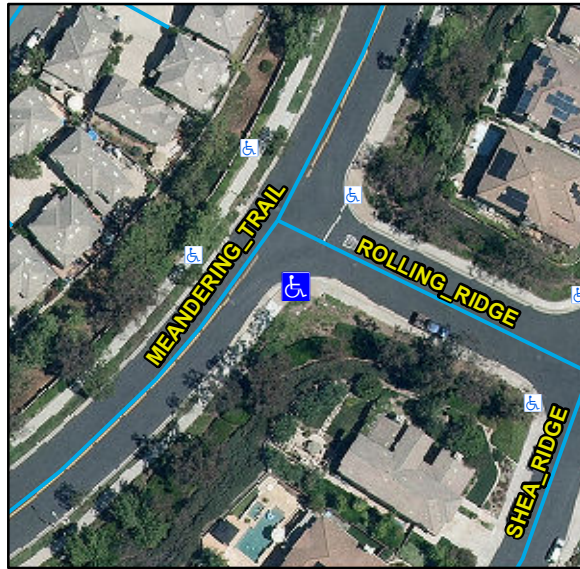
| Compliance | Description | Data | Compliance | Description | Data |
|---|---|---|---|---|---|
| <b>No</b> | Ramp Cross Slope LT (%) | <b>7.4</b> | <b>No</b> | Ramp Cross Slope RT (%) | <b>8.2</b> |
| <b>No</b> | Gutter Lip Height (in) | <b>2</b> | | Road Run Slope (%) | <b>0.8</b> |

**Remove & Replace Curb Ramp With Two New Directional Ramps or Equivalent. Grind Gutter Lip.**

**R204.3, R304.5.3, R302.7.2, STD 1115**
