# Access Compliance Report Public Rights-of-Way (Curb Ramps)

Main Street: MEANDERING\_TRAIL Cross Street: BALMORAL\_PL Location: SW

ADA ID: RPRK211019144249 Ramp Type: Type 1 - Perpendicular Diagonal Initial Pass/Fail: Fail Overall Compliance: No Severity Score: 16

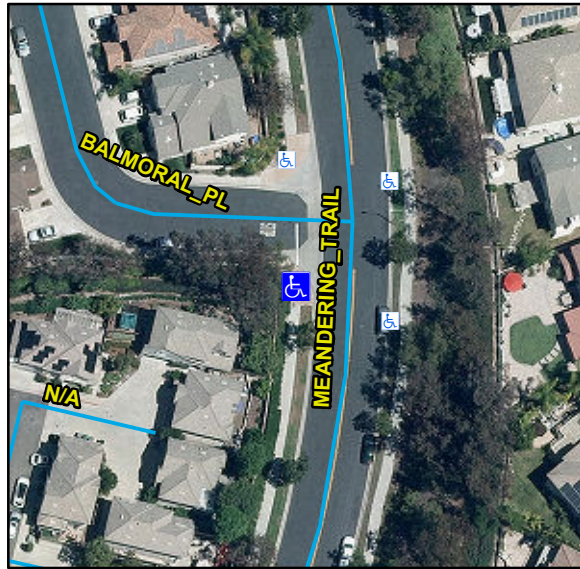
| Compliance | Description | Data | Compliance | Description | Data |
|---|---|---|---|---|---|
| No | Ramp Run Slope (%) | 8.4 | N/A | Flare Slope LT (%) | N/A |
| No | Ramp Cross Slope (%) | 2.3 | N/A | Flare Traversable LT | N/A |

Remove & Replace Curb Ramp With Two New Directional Ramps or Equivalent.

R304.2.2, R304.5.3, STD 1115
