# Access Compliance Report Public Rights-of-Way (Curb Ramps)

Main Street: BALMORAL\_PL Cross Street: MEANDERING\_TRAIL Location: NW

ADA ID: RPRK211019144431 Ramp Type: Type 4 - Parallel Initial Pass/Fail: Fail Overall Compliance: No Severity Score: 30

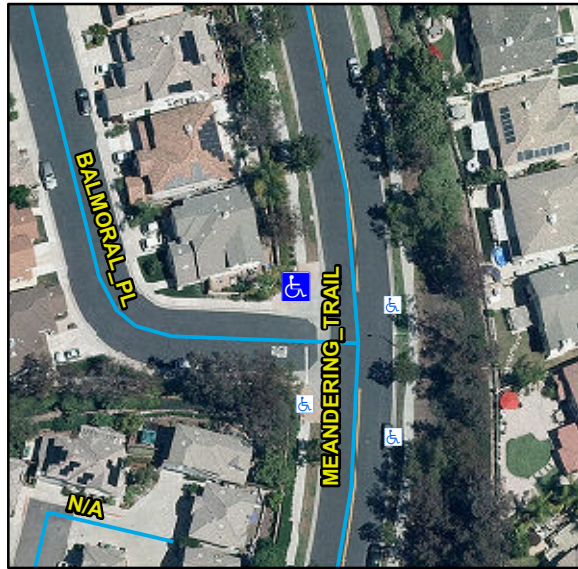
| Compliance | Description | Data | Compliance | Description | Data |
|---|---|---|---|---|---|
| No | Ramp Cross Slope LT (%) | 11.3 | No | Ramp Cross Slope RT (%) | 9.2 |

Remove & Replace Curb Ramp With Two New Directional Ramps or Equivalent.

R204.3, R304.5.3, STD 1115
