# Access Compliance Report Public Rights-of-Way (Curb Ramps)

Main Street: EDMONTON\_WAY Cross Street: CHANDLER\_PL Location: SE

ADA ID: RPRK211019145002 Ramp Type: Type 4 - Parallel Initial Pass/Fail: Fail Overall Compliance: No Severity Score: 34

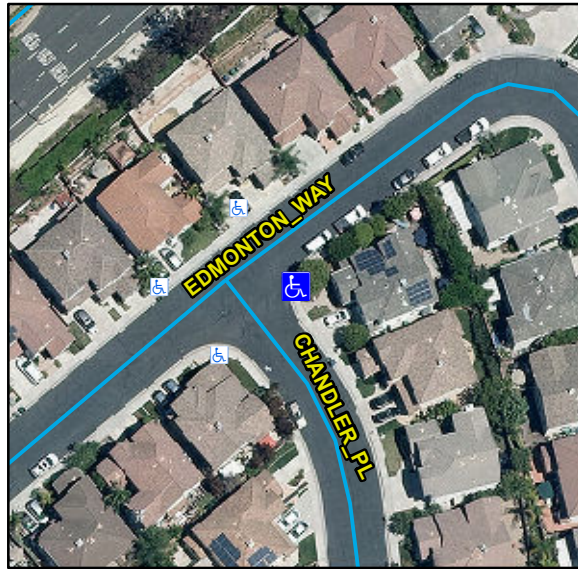
| Compliance | Description | Data | Compliance | Description | Data |
|---|---|---|---|---|---|
| N/A | Ramp Length LT (in) | 114 | N/A | Ramp Length RT (in) | 108 |
| Yes | Ramp Width LT (in) | 48 | No | Ramp Width RT (in) | 47 |
| Yes | Ramp Run Slope LT (%) | 3.7 | Yes | Ramp Run Slope RT (%) | 3.7 |
| No | Ramp Cross Slope LT (%) | 13.8 | No | Ramp Cross Slope RT (%) | 13.9 |
| N/A | Gutter Ponding | N/A | No | Curb Slope | 10.1 |
| N/A | Gutter Cross Slope (%) | N/A | No | Perpendicular Joint Present | No |

**Remove & Replace Curb Ramp With Two New Directional Ramps or Equivalent.**

**R304.2.2, R204.3, R304.5.1, R304.5.3, STD 1115**

Total Cost: \$ 4000
