# Access Compliance Report Public Rights-of-Way (Curb Ramps)

Main Street: **OSO\_PKWY** Cross Street: **MEANDERING\_TRAIL** Location: **NW**

ADA ID: **RPRK211019150808** Ramp Type: **Type 1 - Perpendicular Diagonal** Initial Pass/Fail: **Fail** Overall Compliance: **No** Severity Score: **30**

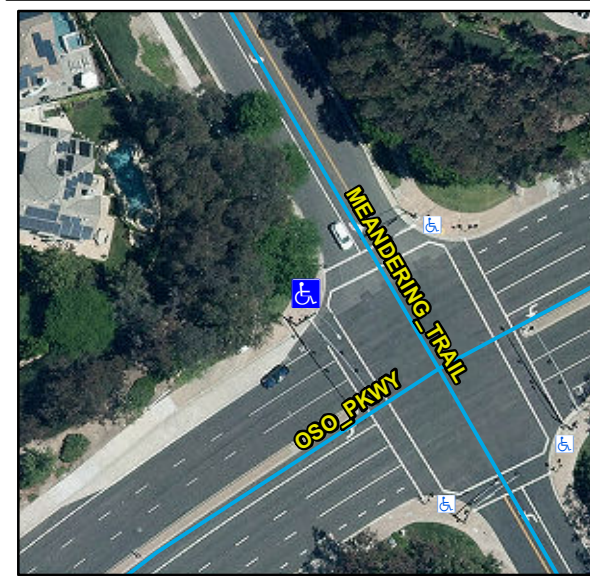
| Compliance | Description | Data | Compliance | Description | Data |
|---|---|---|---|---|---|
| No | Ramp Cross Slope (%) | 7.5 | N/A | Flare Traversable LT | N/A |

Possible Solutions:  
**Remove & Replace Curb Ramp With Two New Directional Ramps or Equivalent.**

OC Std/PROW:  
**R304.2.2, R204.3, R304.5.3, STD 1115**
