# Access Compliance Report Public Rights-of-Way (Curb Ramps)

| Main Street: MEANDERING_TRAIL | | Cross Street: OSO_PKWY | | Location: | NE |
| ADA ID: RPRK211019151231 | Ramp Type: Type 4 - Parallel | Initial Pass/Fail: Fail | Overall Compliance: No | Severity Score: | 45 |

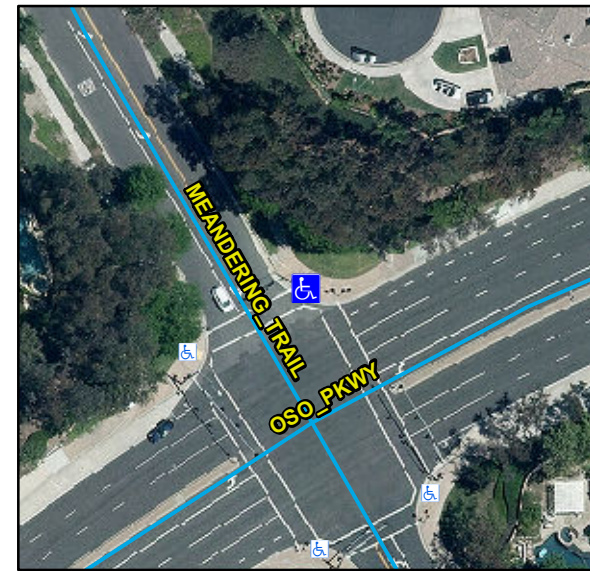
**R204.3, R304.5.3, R304.3.2, STD 1115**

| Compliance | Description | Data | Compliance | Description | Data |
|---|---|---|---|---|---|
| Yes | Ramp Run Slope LT (%) | 3.5 | No | Ramp Run Slope RT (%) | 14.5 |
| No | Ramp Cross Slope LT (%) | 6.9 | No | Ramp Cross Slope RT (%) | 6.4 |

**Remove & Replace Curb Ramp With Two New Directional Ramps or Equivalent.**

Total Cost: \$ 4000
