# Access Compliance Report Public Rights-of-Way (Curb Ramps)

| Main Street: <b>OSO_PKWY</b> | | Cross Street: <b>MEANDERING_TRAIL</b> | | Location: <b>SE</b> |
| ADA ID: <b>RPRK211019151738</b> | Ramp Type: <b>Type 4 - Parallel</b> | Initial Pass/Fail: <b>Fail</b> | Overall Compliance: <b>No</b> | Severity Score: <b>45</b> |

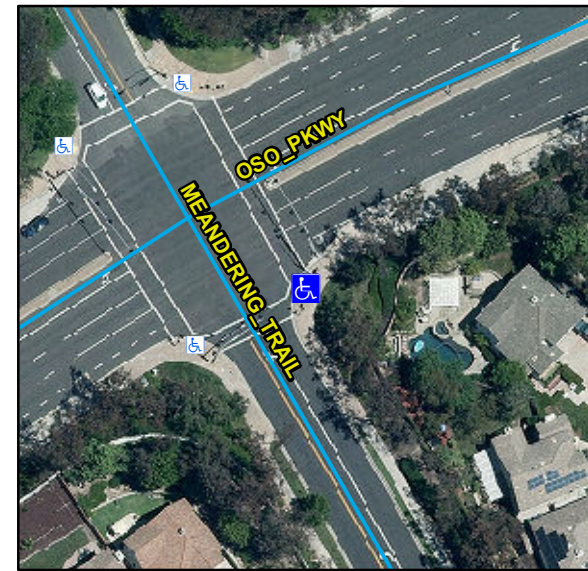
| Compliance | Description | Data | Compliance | Description | Data |
|---|---|---|---|---|---|
| <b>No</b> | Ramp Run Slope LT (%) | <b>8.4</b> | <b>Yes</b> | Ramp Run Slope RT (%) | <b>6.3</b> |
| <b>No</b> | Ramp Cross Slope LT (%) | <b>8</b> | <b>No</b> | Ramp Cross Slope RT (%) | <b>7.4</b> |

**Remove & Replace Curb Ramp With Two New Directional Ramps or Equivalent.**

**R204.3, R304.3.2, R304.5.3, STD 1115**

Total Cost: \$ **4000**
