# Access Compliance Report Public Rights-of-Way (Curb Ramps)

Main Street: EDELWEISS Cross Street: MORNING\_TRAIL Location: SW

ADA ID: RPRK211019172346 Ramp Type: Type 4 - Parallel Initial Pass/Fail: Fail Overall Compliance: No Severity Score: 45

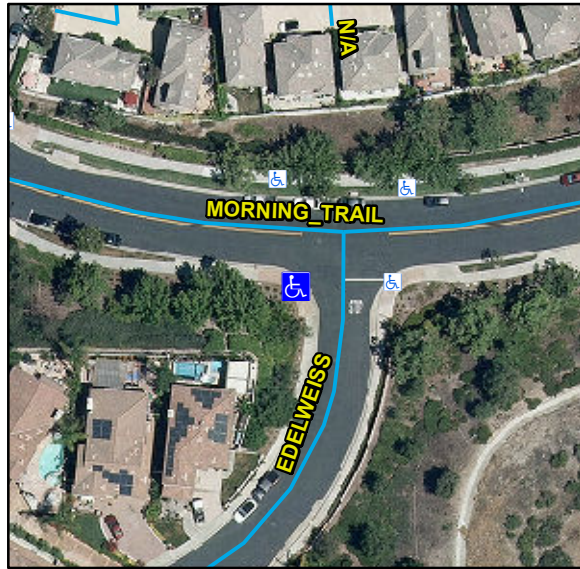
| Compliance | Description | Data | Compliance | Description | Data |
|---|---|---|---|---|---|
| No | Ramp Run Slope LT (%) | 9.6 | Yes | Ramp Run Slope RT (%) | 7.6 |
| No | Ramp Cross Slope LT (%) | 7.5 | No | Ramp Cross Slope RT (%) | 9.2 |
| No | Gutter Lip Height (in) | 0.25 | | Road Run Slope (%) | 7 |

Remove & Replace Curb Ramp With Two New Directional Ramps or Equivalent. Grind Gutter Lip.
