# Access Compliance Report Public Rights-of-Way (Curb Ramps)

Main Street: MORNING\_TRAIL Cross Street: EDELWEISS Location: SE

ADA ID: RPRK211019172627 Ramp Type: Type 4 - Parallel Initial Pass/Fail: Fail Overall Compliance: No Severity Score: 30

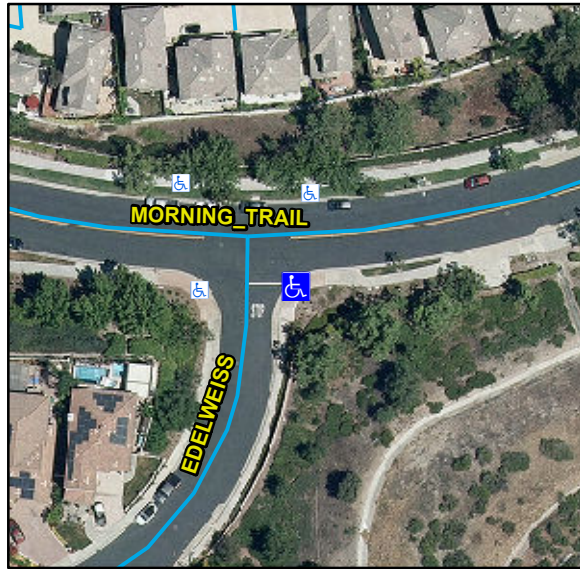
| Compliance | Description | Data | Compliance | Description | Data |
|---|---|---|---|---|---|
| No | Ramp Cross Slope LT (%) | 11.3 | No | Ramp Cross Slope RT (%) | 8.4 |

**Remove & Replace Curb Ramp With Two New Directional Ramps or Equivalent.**

**R204.3, R304.5.3, STD 1115**
