# Access Compliance Report Public Rights-of-Way (Curb Ramps)

Main Street: FREESIA Cross Street: EDELWEISS Location: SW

ADA ID: RPRK211019173122 Ramp Type: Type 4 - Parallel Initial Pass/Fail: Fail Overall Compliance: No Severity Score: 2

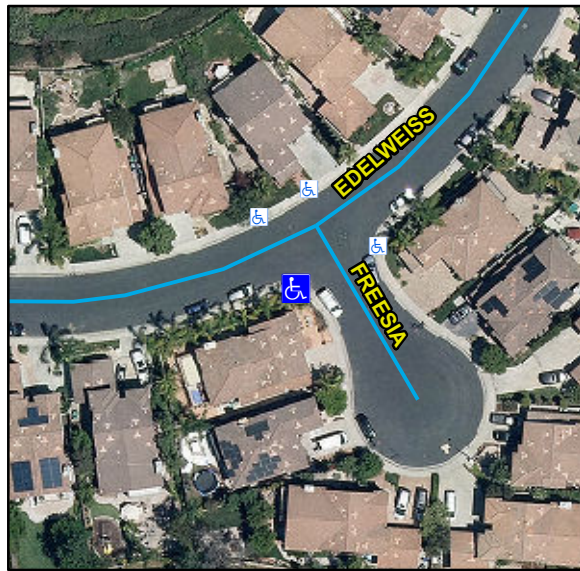
| Compliance | Description | Data | Compliance | Description | Data |
|---|---|---|---|---|---|
| Yes | Ramp Run Slope LT (%) | 7.1 | Yes | Ramp Run Slope RT (%) | 1.2 |
| No | Ramp Cross Slope LT (%) | 3.6 | No | Ramp Cross Slope RT (%) | 2.3 |

**Remove & Replace Curb Ramp With Two New Directional Ramps or Equivalent.**

**R204.3, R304.5.3, STD 1115**
