# Access Compliance Report Public Rights-of-Way (Curb Ramps)

Main Street: EDELWEISS Cross Street: FREESIA Location: SE

ADA ID: RPRK211019173331 Ramp Type: Type 4 - Parallel Initial Pass/Fail: Fail Overall Compliance: No Severity Score: 5

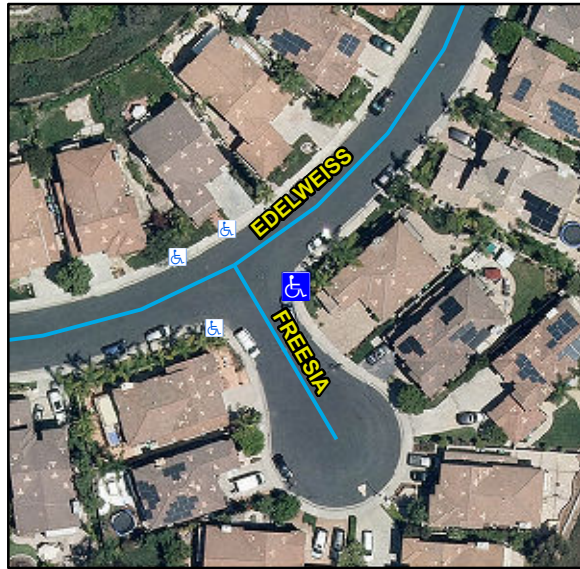
| Compliance | Description | Data | Compliance | Description | Data |
|---|---|---|---|---|---|
| No | Ramp Width LT (in) | 47 | No | Ramp Width RT (in) | 47 |
| No | Ramp Cross Slope LT (%) | 3 | Yes | Ramp Cross Slope RT (%) | 1.5 |

**Remove & Replace Curb Ramp With Two New Directional Ramps or Equivalent.**

**R204.3, R304.5.1, R304.5.3, STD 1115**

Total Cost: \$ 4000
