# Access Compliance Report Public Rights-of-Way (Curb Ramps)

| Main Street: MORNING_TRAIL | | Cross Street: CRYSTALAIRE | | Location: | S |
| ADA ID: RPRK211019173800 | Ramp Type: Type 4 - Parallel | Initial Pass/Fail: Fail | Overall Compliance: No | Severity Score: | 30 |

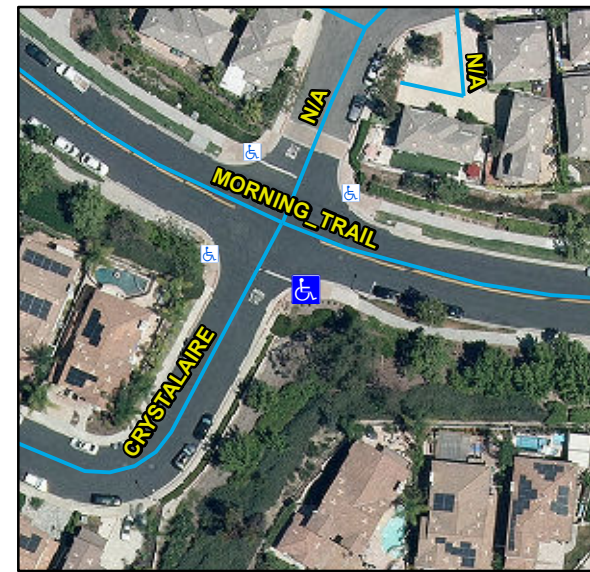
| Compliance | Description | Data | Compliance | Description | Data |
|---|---|---|---|---|---|
| No | Ramp Cross Slope LT (%) | 13.1 | No | Ramp Cross Slope RT (%) | 9.3 |

**Remove & Replace Curb Ramp With Two New Directional Ramps or Equivalent.**

**R204.3, R304.5.3, STD 1115**

Total Cost: \$ 4000
