# Access Compliance Report Public Rights-of-Way (Curb Ramps)

Main Street: CRYSTALAIRE Cross Street: MORNING\_TRAIL Location: W

ADA ID: RPRK211019174034 Ramp Type: Type 4 - Parallel Initial Pass/Fail: Fail Overall Compliance: No Severity Score: 45

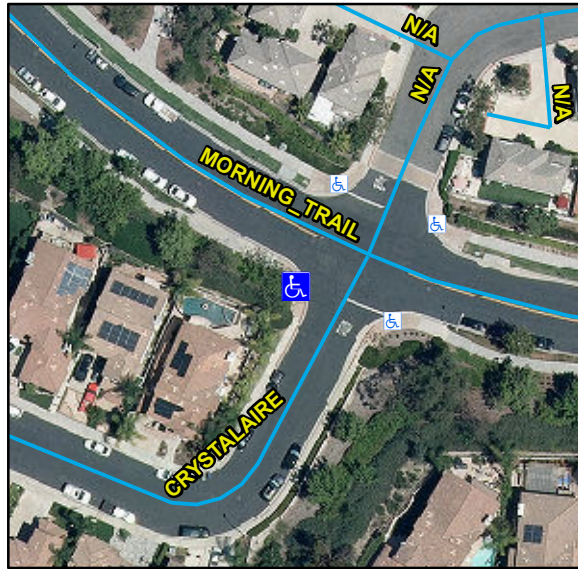
| Compliance | Description | Data | Compliance | Description | Data |
|---|---|---|---|---|---|
| No | Ramp Run Slope LT (%) | 8.7 | Yes | Ramp Run Slope RT (%) | 7.2 |
| No | Ramp Cross Slope LT (%) | 11.3 | No | Ramp Cross Slope RT (%) | 9.7 |
| N/A | Gutter Cross Slope (%) | N/A | No | Perpendicular Joint Present | No |

Remove & Replace Curb Ramp With Two New Directional Ramps or Equivalent.

R204.3, R304.3.2, R304.5.3, STD 1115

Total Cost: \$ 2500
