# Access Compliance Report Public Rights-of-Way (Curb Ramps)

Main Street: MORNING\_TRAIL Cross Street: BEL\_FLORA Location: SW

ADA ID: RPRK211019174519 Ramp Type: Type 4 - Parallel Initial Pass/Fail: Fail Overall Compliance: No Severity Score: 45

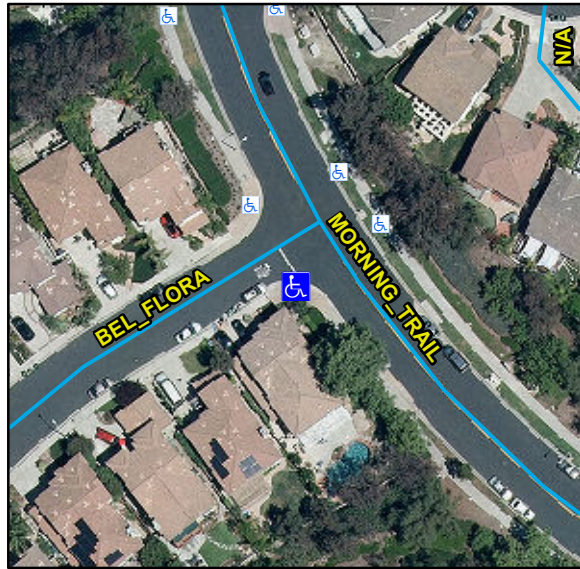
| Compliance | Description | Data | Compliance | Description | Data |
|---|---|---|---|---|---|
| No | Ramp Run Slope LT (%) | 8.6 | Yes | Ramp Run Slope RT (%) | 2 |
| No | Ramp Cross Slope LT (%) | 11.8 | No | Ramp Cross Slope RT (%) | 10.4 |
| No | Gutter Lip Height (in) | 0.25 | | Road Run Slope (%) | 5.1 |

Remove & Replace Curb Ramp With Two New Directional Ramps or Equivalent. Grind Gutter Lip.

R204.3, R304.3.2, R304.5.3, R302.7.2, STD 1115
