# Access Compliance Report Public Rights-of-Way (Curb Ramps)

Main Street: BEL\_FLORA Cross Street: MORNING\_TRAIL Location: NW

ADA ID: RPRK211019174717 Ramp Type: Type 4 - Parallel Initial Pass/Fail: Fail Overall Compliance: No Severity Score: 45

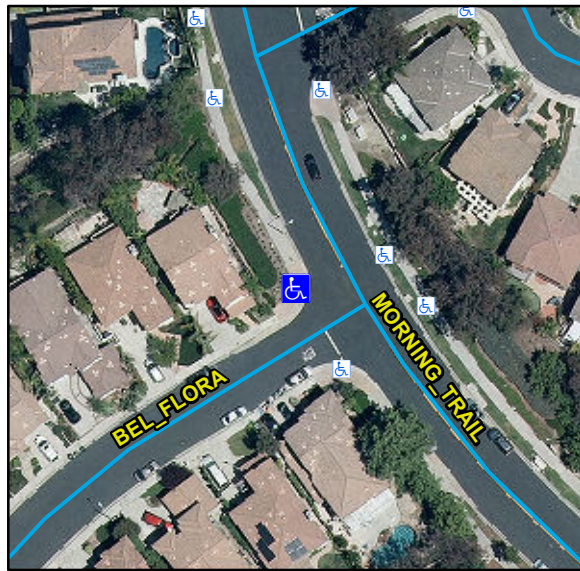
| Compliance | Description | Data | Compliance | Description | Data |
|---|---|---|---|---|---|
| No | Ramp Run Slope LT (%) | 8.9 | Yes | Ramp Run Slope RT (%) | 5.7 |
| No | Ramp Cross Slope LT (%) | 9.1 | No | Ramp Cross Slope RT (%) | 9.5 |
| No | Gutter Lip Height (in) | 0.5 | | Road Run Slope (%) | 6 |

**Remove & Replace Curb Ramp With Two New Directional Ramps or Equivalent. Grind Gutter Lip.**

**R204.3, R304.3.2, R304.5.3, R302.7.2, STD 1115**
