# Access Compliance Report Public Rights-of-Way (Curb Ramps)

Main Street: BEL\_FLORA Cross Street: CALADIUM Location: SE

ADA ID: RPRK211019175125 Ramp Type: Type 4 - Parallel Initial Pass/Fail: Fail Overall Compliance: No Severity Score: 4

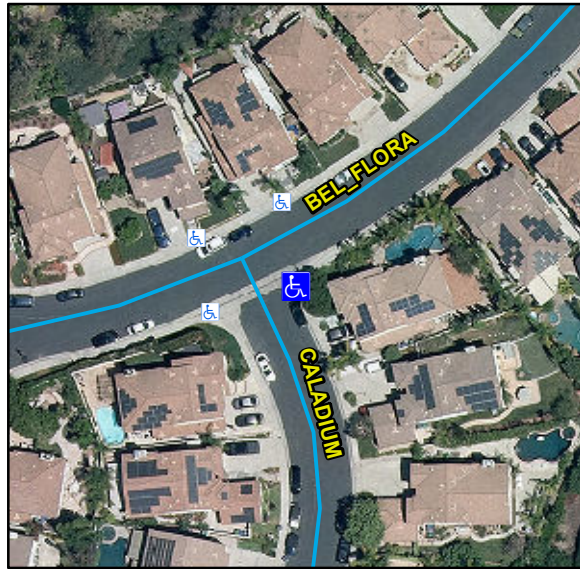
| Compliance | Description | Data | Compliance | Description | Data |
|---|---|---|---|---|---|
| No | Ramp Width LT (in) | 47 | Yes | Ramp Width RT (in) | 48 |
| N/A | Gutter Cross Slope (%) | N/A | No | Perpendicular Joint Present | No |

**Remove & Replace Curb Ramp With Two New Directional Ramps or Equivalent.**

**R204.3, R304.5.1, STD 1115**

Total Cost: \$ 4000
