# Access Compliance Report Public Rights-of-Way (Curb Ramps)

Main Street: CALADIUM Cross Street: BEL\_FLORA Location: SW

ADA ID: RPRK211019175335 Ramp Type: Type 4 - Parallel Initial Pass/Fail: Pass Overall Compliance: No Severity Score: 20

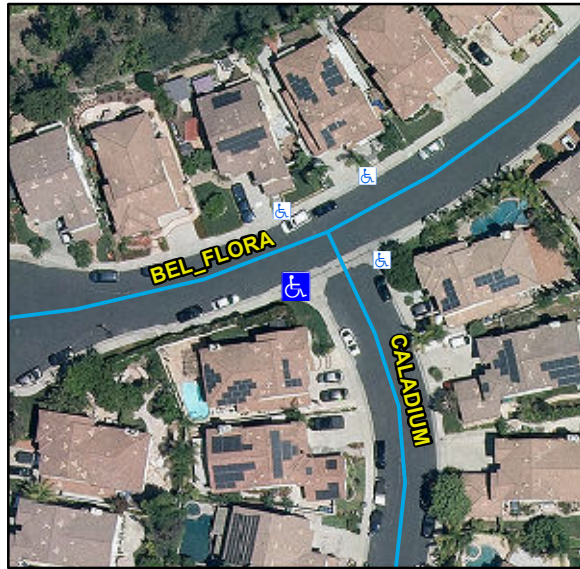
R204.3, R304.2.1, R304.2.2-Perp, R304.3.2-Para, R304.5.3, R305, STD 1115

Remove & Replace Curb Ramp With Two New Directional Ramps or Equivalent. Remove & Replace Gutter.
