# Access Compliance Report Public Rights-of-Way (Curb Ramps)

Main Street: **RADIANCE\_LN** Cross Street: **MORNING\_TRAIL** Location: **SE**

ADA ID: **RPRK211019175904** Ramp Type: **Type 1 - Perpendicular Diagonal Initial Pass/Fail: Fail** Overall Compliance: **No** Severity Score: **2**

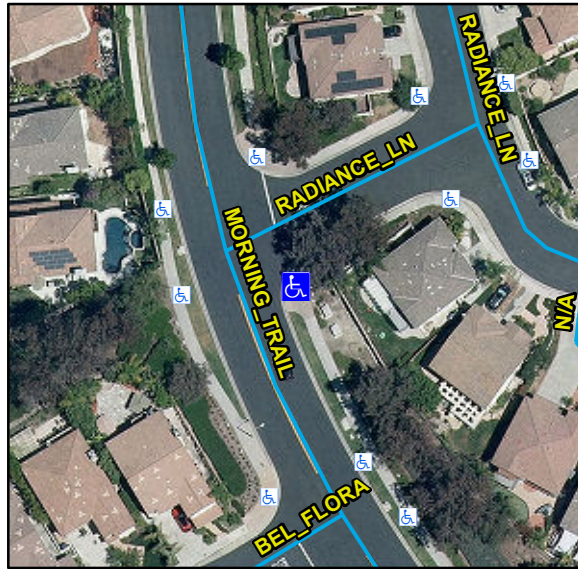
| Compliance | Description | Data | Compliance | Description | Data |
|---|---|---|---|---|---|
| No | Ramp Cross Slope (%) | 2.7 | N/A | Flare Traversable LT | N/A |

**Remove & Replace Curb Ramp With Two New Directional Ramps or Equivalent.**

**R304.2.2, R304.5.3, STD 1115**
