# Access Compliance Report Public Rights-of-Way (Curb Ramps)

Main Street: MORNING\_TRAIL Cross Street: RADIANCE\_LN Location: NE

ADA ID: RPRK211019180038 Ramp Type: Type 4 - Parallel Initial Pass/Fail: Fail Overall Compliance: No Severity Score: 15

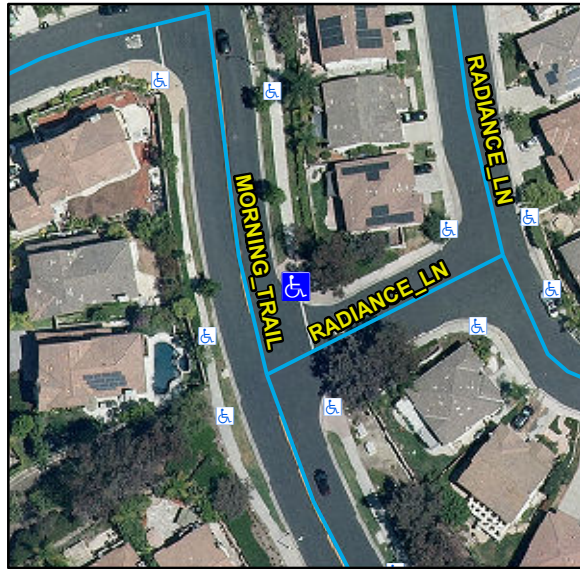
| Compliance | Description | Data | Compliance | Description | Data |
|---|---|---|---|---|---|
| No | Ramp Cross Slope LT (%) | 4.6 | No | Ramp Cross Slope RT (%) | 5.5 |

Remove & Replace Curb Ramp With Two New Directional Ramps or Equivalent.

R204.3, R304.5.3, STD 1115
