# Access Compliance Report Public Rights-of-Way (Curb Ramps)

| Main Street: <b>RADIANCE_LN</b> | | Cross Street: <b>DANCING_CLOUD_CT</b> | | Location: <b>NW</b> |
| ADA ID: <b>RPRK211019180433</b> | Ramp Type: <b>Type 4 - Parallel</b> | Initial Pass/Fail: <b>Fail</b> | Overall Compliance: <b>No</b> | Severity Score: <b>2</b> |

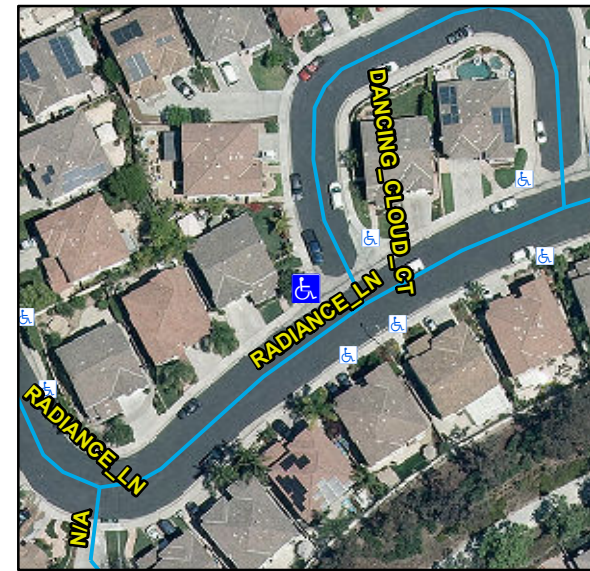
| Compliance | Description | Data | Compliance | Description | Data |
|---|---|---|---|---|---|
| <b>Yes</b> | Ramp Cross Slope LT (%) | <b>0.7</b> | <b>No</b> | Ramp Cross Slope RT (%) | <b>2.2</b> |
| <b>N/A</b> | Gutter Ponding | <b>N/A</b> | <b>No</b> | Curb Slope | <b>8.4</b> |

**Remove & Replace Curb Ramp With Two New Directional Ramps or Equivalent.**

**R304.2.2, R204.3, R304.5.3, STD 1115**

Total Cost: \$ **4000**
