# Access Compliance Report Public Rights-of-Way (Curb Ramps)

Main Street: DANCING\_CLOUD\_CT Cross Street: RADIANCE\_LN Location: NE

ADA ID: RPRK211019180652 Ramp Type: Type 4 - Parallel Initial Pass/Fail: Fail Overall Compliance: No Severity Score: 2

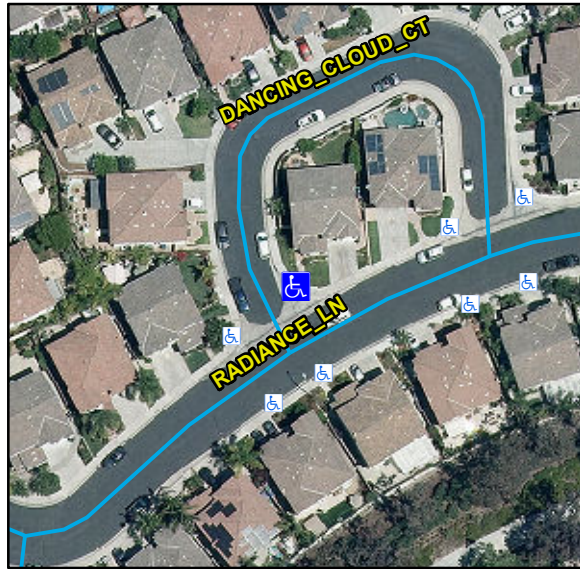
| Compliance | Description | Data | Compliance | Description | Data |
|---|---|---|---|---|---|
| No | Ramp Cross Slope LT (%) | 2.2 | Yes | Ramp Cross Slope RT (%) | 2 |

Remove & Replace Curb Ramp With Two New Directional Ramps or Equivalent.

R204.3, R304.5.3, STD 1115
