# Access Compliance Report Public Rights-of-Way (Curb Ramps)

Main Street: **RADIANCE\_LN** Cross Street: **DANCING\_CLOUD\_CT** Location: **NW**

ADA ID: **RPRK211019180909** Ramp Type: **Type 4 - Parallel** Initial Pass/Fail: **Fail** Overall Compliance: **No** Severity Score: **15**

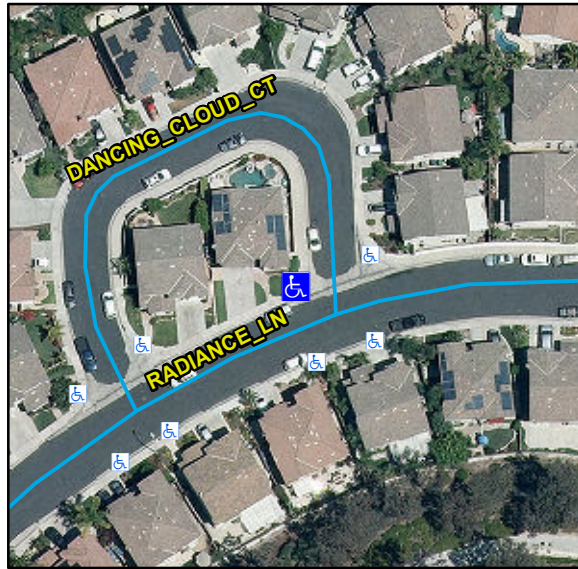
| Compliance | Description | Data | Compliance | Description | Data |
|---|---|---|---|---|---|
| <b>Yes</b> | Ramp Run Slope LT (%) | <b>3.5</b> | <b>No</b> | Ramp Run Slope RT (%) | <b>8.7</b> |
| <b>No</b> | Gutter Lip Height (in) | <b>0.25</b> | | Road Run Slope (%) | <b>3.3</b> |

**Remove & Replace Curb Ramp With Two New Directional Ramps or Equivalent. Grind Gutter Lip.**
