# Access Compliance Report Public Rights-of-Way (Curb Ramps)

Main Street: DANCING\_CLOUD\_CT Cross Street: RADIANCE\_LN Location: NE

ADA ID: RPRK211019181110 Ramp Type: Type 4 - Parallel Initial Pass/Fail: Pass Overall Compliance: No Severity Score: 22

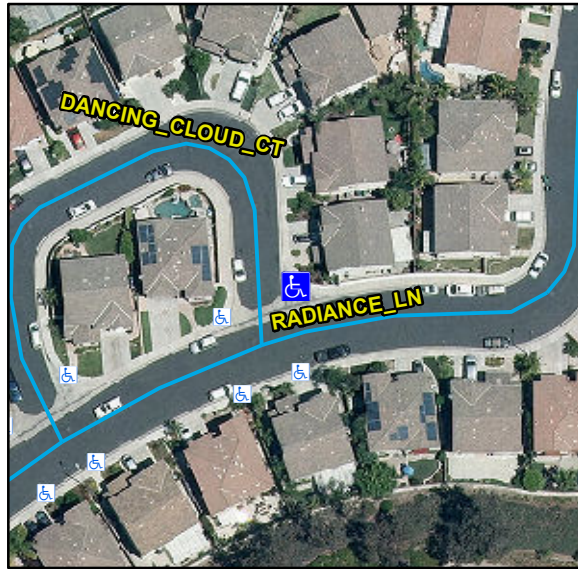
| Compliance | Description | Data | Compliance | Description | Data |
|---|---|---|---|---|---|
| No | Ramp Cross Slope LT (%) | 2.3 | No | Ramp Cross Slope RT (%) | 4.1 |
| No | Gutter Lip Height (in) | 0.25 | | Road Run Slope (%) | 0.5 |

Remove & Replace Curb Ramp With Two New Directional Ramps or Equivalent. Grind Gutter Lip.
