# Access Compliance Report Public Rights-of-Way (Curb Ramps)

Main Street: **RADIANCE\_LN** Cross Street: **RADIANCE\_LN** Location: **NW**

ADA ID: **RPRK211019181631** Ramp Type: **Type 4 - Parallel** Initial Pass/Fail: **Fail** Overall Compliance: **No** Severity Score: **19**

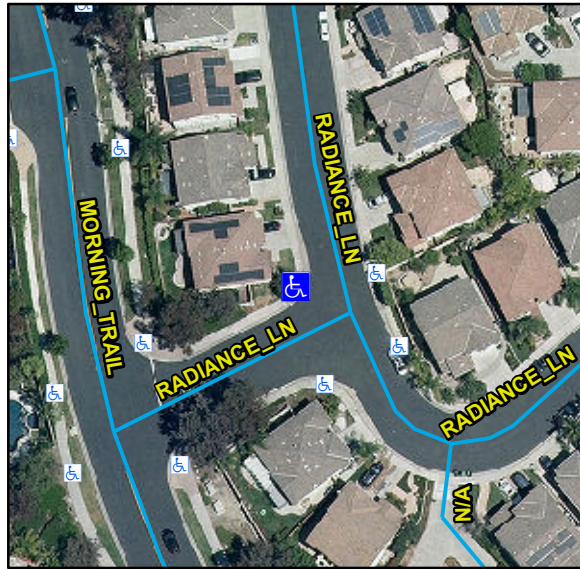
| Compliance | Description | Data | Compliance | Description | Data |
|---|---|---|---|---|---|
| <b>No</b> | Ramp Width LT (in) | <b>47</b> | <b>No</b> | Ramp Width RT (in) | <b>47</b> |
| <b>No</b> | Ramp Run Slope LT (%) | <b>10.7</b> | <b>Yes</b> | Ramp Run Slope RT (%) | <b>1</b> |

**Remove & Replace Curb Ramp With Two New Directional Ramps or Equivalent.**
