# Access Compliance Report Public Rights-of-Way (Curb Ramps)

Main Street: **RADIANCE\_LN** Cross Street: **RADIANCE\_LN** Location: **SW**

ADA ID: **RPRK211019181829** Ramp Type: **Type 4 - Parallel** Initial Pass/Fail: **Pass** Overall Compliance: **No** Severity Score: **26**

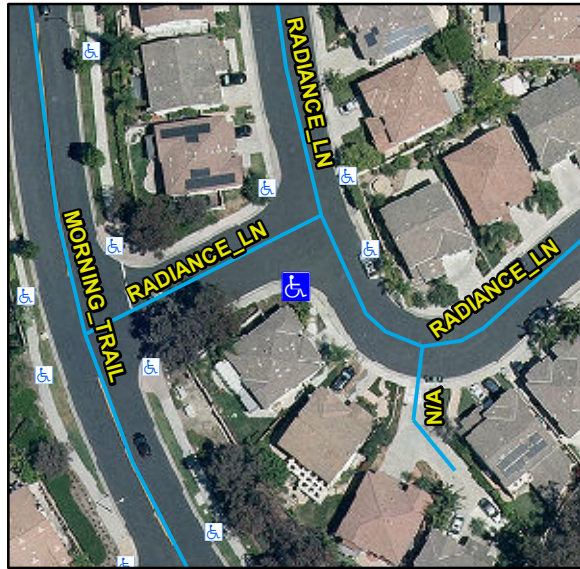
| Compliance | Description | Data | Compliance | Description | Data |
|---|---|---|---|---|---|
| <b>No</b> | Ramp Cross Slope LT (%) | <b>2.6</b> | <b>No</b> | Ramp Cross Slope RT (%) | <b>2.7</b> |
| <b>No</b> | Gutter Run Slope (%) | <b>9.6</b> | | Road Cross Slope (%) | <b>3.3</b> |

**Remove & Replace Curb Ramp With Two New Directional Ramps or Equivalent. Remove & Replace Gutter.**
