# Access Compliance Report Public Rights-of-Way (Curb Ramps)

| Main Street: THORNHILL_ST | | Cross Street: BENJAMIN_DR | | Location: | W |
| ADA ID: RPRK211020135432 | Ramp Type: Blended Transition 2 | Initial Pass/Fail: Fail | Overall Compliance: No | Severity Score: | 30 |

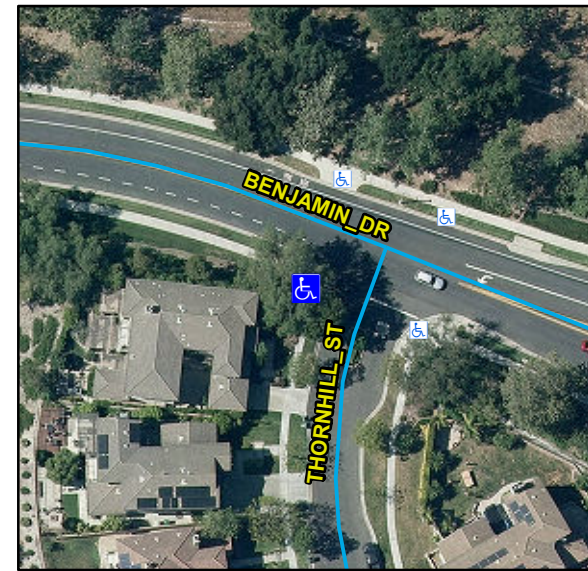
| Compliance | Description | Data | Compliance | Description | Data |
|---|---|---|---|---|---|
| No | Ramp Cross Slope (%) | 9.6 | N/A | Flare Traversable RT | N/A |

Possible Solutions:

**Remove & Replace Curb Ramp With Two New Directional Ramps or Equivalent.**

**R204.3, R304.5.3, STD 1115**
