# Access Compliance Report Public Rights-of-Way (Curb Ramps)

Main Street: ANTONIO\_PKWY Cross Street: DEERPATH Location: E

ADA ID: RPRK211020151809 Ramp Type: Type 1 - Perpendicular Diagonal Initial Pass/Fail: Fail Overall Compliance: No Severity Score: 30

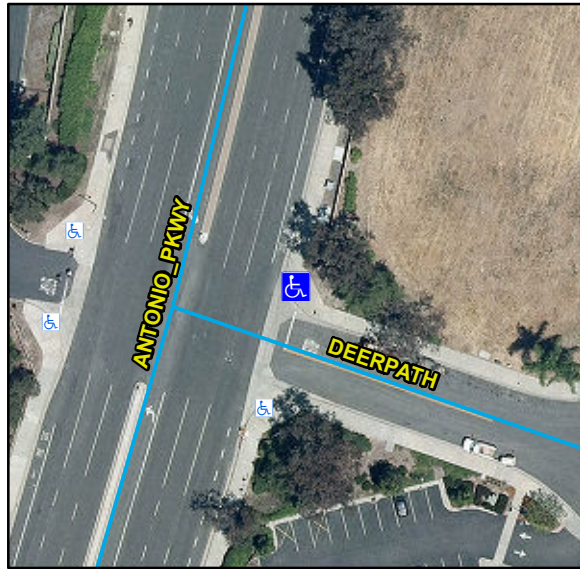
| Compliance | Description | Data | Compliance | Description | Data |
|---|---|---|---|---|---|
| No | Ramp Run Slope (%) | 10.7 | N/A | Flare Slope LT (%) | N/A |
| No | Ramp Cross Slope (%) | 5.2 | N/A | Flare Traversable LT | N/A |
| No | Gutter Lip Height (in) | 0.25 | | Road Run Slope (%) | 3.7 |

Remove & Replace Curb Ramp With Two New Directional Ramps or Equivalent.

R304.2.2, R204.3, R304.5.3, R302.7.2, STD 1115
