# Access Compliance Report Public Rights-of-Way (Curb Ramps)

Main Street: DEERPATH Cross Street: ANTONIO\_PKWY Location: S

ADA ID: RPRK211020152000 Ramp Type: Type 1 - Perpendicular Diagonal Initial Pass/Fail: Fail Overall Compliance: No Severity Score: 15

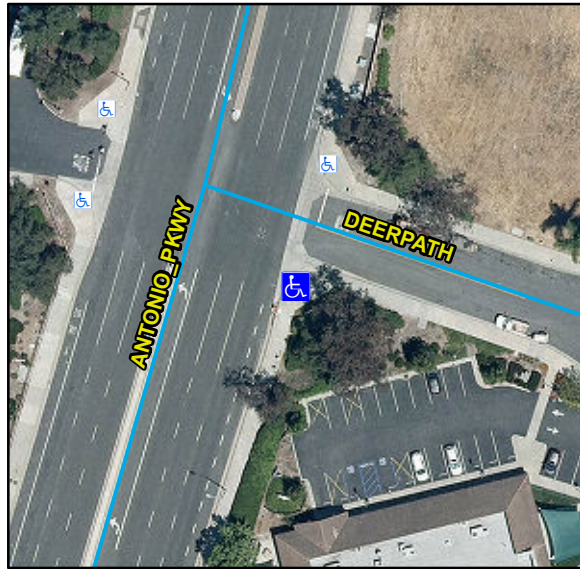
| Compliance | Description | Data | Compliance | Description | Data |
|---|---|---|---|---|---|
| No | Ramp Run Slope (%) | 9.8 | N/A | Flare Slope LT (%) | N/A |
| No | Gutter Lip Height (in) | 0.25 | | Road Run Slope (%) | 0.9 |

Remove & Replace Curb Ramp With Two New Directional Ramps or Equivalent.

R304.2.2, R204.3, R302.7.2, STD 1115
