# Access Compliance Report Public Rights-of-Way (Curb Ramps)

Main Street: EDENDALE\_ST Cross Street: WYNDHAM\_ST Location: W

ADA ID: RPRK211020152652 Ramp Type: Type 4 - Parallel Initial Pass/Fail: Pass Overall Compliance: No Severity Score: 25

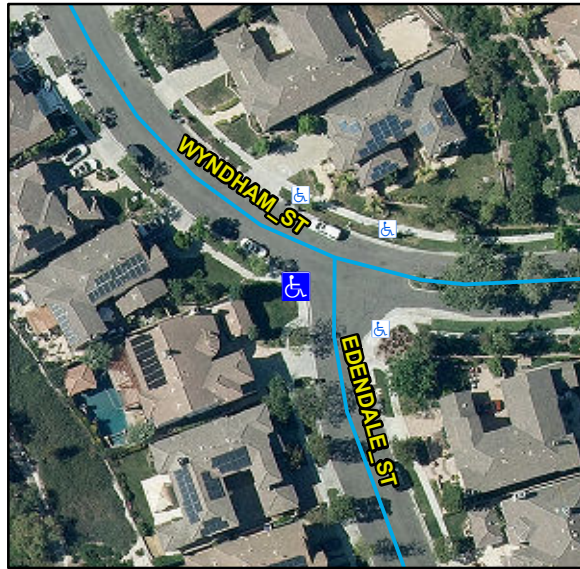
| Compliance | Description | Data | Compliance | Description | Data |
|---|---|---|---|---|---|
| N/A | Landing Present | No | No | DWS Provided | No |
| No | Landing Width (in) | N/A | N/A | DWS Length (in) | N/A |
| No | Landing Run Slope (%) | N/A | N/A | DWS Full Width | N/A |
| No | Landing Cross Slope (%) | N/A | | DWS Offset Type | N/A |
| No | Gutter Run Slope (%) | 7.6 | | Road Cross Slope (%) | 3.7 |

**Remove & Replace Curb Ramp With Two New Directional Ramps or Equivalent. Remove & Replace Gutter.**

**R204.3, R304.2.1, R304.2.2-Perp, R304.3.2-Para, R304.5.3, R305, R304.5.4, STD 1115**
