Access Compliance Report Public Rights-of-Way (Curb Ramps)

Main Street: WYNDHAM_ST **Cross Street:** EDENDALE_ST **Location:** S

ADA ID: RPRK211020152909 **Ramp Type:** Type 4 - Parallel **Initial Pass/Fail:** Fail **Overall Compliance:** No **Severity Score:** 16

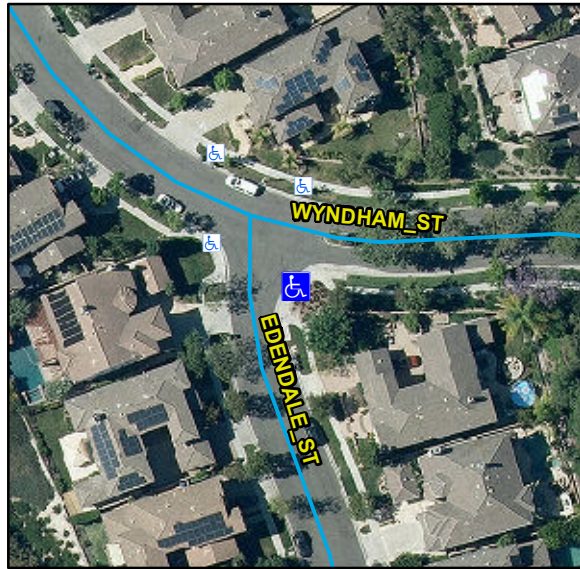
Compliance	Description	Data	Compliance	Description	Data
N/A	Ramp Length LT (in)	121	N/A	Ramp Length RT (in)	116
Yes	Ramp Width LT (in)	55	Yes	Ramp Width RT (in)	54
No	Ramp Run Slope LT (%)	8.4	Yes	Ramp Run Slope RT (%)	0.2
No	Ramp Cross Slope LT (%)	3.1	Yes	Ramp Cross Slope RT (%)	0.9
N/A	Landing Present	N/A	N/A	DWS Provided	N/A
N/A	Landing Length (in)	N/A	N/A	DWS Contrast	N/A
N/A	Landing Width (in)	N/A	N/A	DWS Length (in)	N/A
N/A	Landing Run Slope (%)	N/A	N/A	DWS Full Width	N/A
N/A	Landing Cross Slope (%)	N/A		DWS Offset Type	N/A
N/A	Landing Movement Obstructed?	N/A	N/A	DWS Offset Left (in)	N/A
	Landing Movement Type	N/A	N/A	DWS Offset Right (in)	N/A
N/A	Landing Shared	N/A			
N/A	Clear Space	Yes			
N/A	Clear Space To Crosswalk (in)	N/A			
N/A	Marked Crosswalk 1	No	N/A	Marked Crosswalk 2	No
	Crossing 1 Direction	NE		Crossing 2 Direction	NW
N/A	Marked Crosswalk 1 Width (in)	N/A		Marked Crosswalk 2 Width (in)	N/A

N/A	Ramp Inside Crosswalk 1	N/A	N/A	Ramp Inside Crosswalk 2	N/A
	Crossing 1 Slope (%)	5.1		Crossing 2 Slope (%)	0.4
	Crossing 1 Cross Slope (%)	4.6		Crossing 2 Cross Slope (%)	1.9
N/A	Gutter Ponding	N/A	N/A	Curb Slope	4.9
Yes	Gutter Lip Height (in)	0		Road Run Slope (%)	2.3
N/A	Gutter Run Slope (%)	N/A		Road Cross Slope (%)	2.9
N/A	Gutter Cross Slope (%)	N/A	No	Perpendicular Joint Present	No
Yes	Overall Surface Condition	Acceptable			
	Cross Gutter Present?	No		Spandrel Present?	No
	Replace Cross Gutter?	N/A		Replace Spandrel?	N/A

Possible Solutions:
Remove & Replace Curb Ramp With Two New Directional Ramps or Equivalent.

OC Std/PROW:
 R204.3, R304.3.2, R304.5.3, STD 1115

Total Cost: \$ 4000
