# Access Compliance Report Public Rights-of-Way (Curb Ramps)

Main Street: PLEASANTON\_LN Cross Street: CHANTILLY\_LN Location: NE

ADA ID: RPRK211020153548 Ramp Type: Type 4 - Parallel Initial Pass/Fail: Fail Overall Compliance: No Severity Score: 15

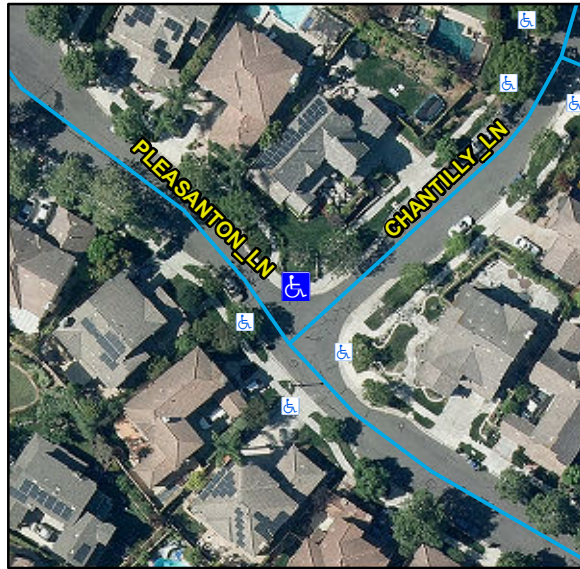
| Compliance | Description | Data | Compliance | Description | Data |
|---|---|---|---|---|---|
| Yes | Ramp Run Slope LT (%) | 5.8 | No | Ramp Run Slope RT (%) | 8.8 |

**Remove & Replace Curb Ramp With Two New Directional Ramps or Equivalent.**
