# Access Compliance Report Public Rights-of-Way (Curb Ramps)

| Main Street: CHANTILLY_LN | | Cross Street: PLEASANTON_LN | | Location: | SE |
| ADA ID: RPRK211020153756 | Ramp Type: Type 4 - Parallel | Initial Pass/Fail: Fail | Overall Compliance: No | Severity Score: | 15 |

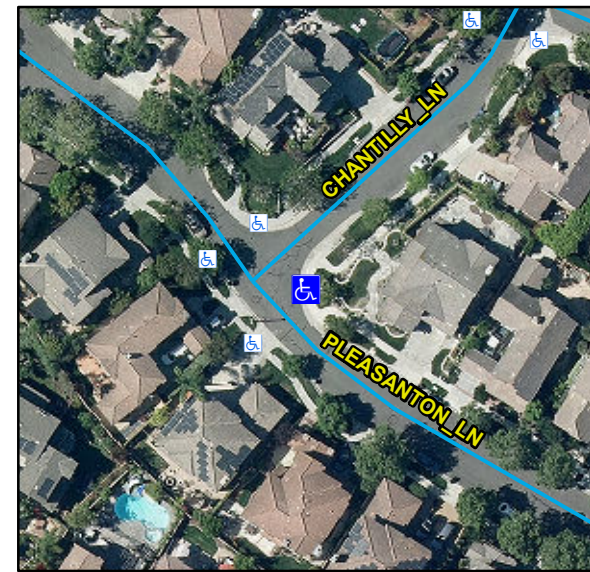
| Compliance | Description | Data | Compliance | Description | Data |
|---|---|---|---|---|---|
| Yes | Ramp Run Slope LT (%) | 5.3 | No | Ramp Run Slope RT (%) | 8.4 |

**Remove & Replace Curb Ramp With Two New Directional Ramps or Equivalent.**

**R204.3, R304.3.2, STD 1115**

Total Cost: \$ 4000
