# Access Compliance Report Public Rights-of-Way (Curb Ramps)

Main Street: WAVERLY\_PL Cross Street: CHANTILLY\_LN Location: S

ADA ID: RPRK211020154017 Ramp Type: Type 4 - Parallel Initial Pass/Fail: Pass Overall Compliance: No Severity Score: 22

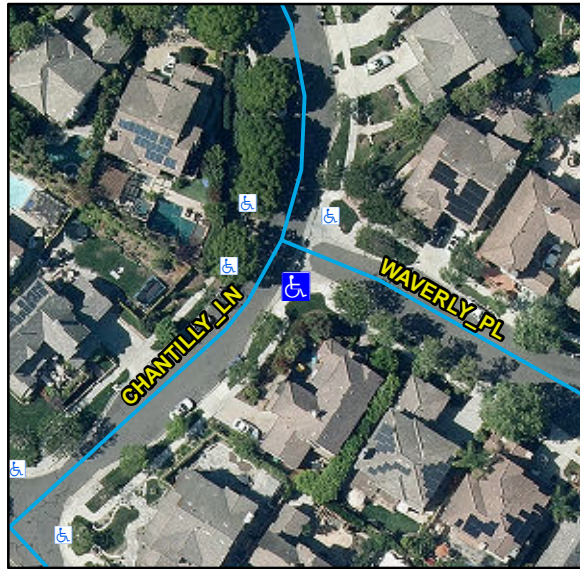
| Compliance | Description | Data | Compliance | Description | Data |
|---|---|---|---|---|---|
| Yes | Ramp Cross Slope LT (%) | 1.1 | No | Ramp Cross Slope RT (%) | 3.5 |
| N/A | Landing Present | No | No | DWS Provided | No |
| No | Landing Width (in) | N/A | N/A | DWS Length (in) | N/A |
| No | Landing Run Slope (%) | N/A | N/A | DWS Full Width | N/A |
| No | Landing Cross Slope (%) | N/A | | DWS Offset Type | N/A |

**Remove & Replace Curb Ramp With Two New Directional Ramps or Equivalent.**

**R204.3, R304.5.3, R304.2.1, R304.2.2-Perp, R304.3.2-Para, R305, STD 1115**

Total Cost: \$ 4000
