# Access Compliance Report Public Rights-of-Way (Curb Ramps)

| Main Street: <b>CHANTILLY_LN</b> | | Cross Street: <b>WAVERLY_PL</b> | | Location: <b>E</b> |
| ADA ID: <b>RPRK211020154400</b> | Ramp Type: <b>Type 4 - Parallel</b> | Initial Pass/Fail: <b>Fail</b> | Overall Compliance: <b>No</b> | Severity Score: <b>2</b> |

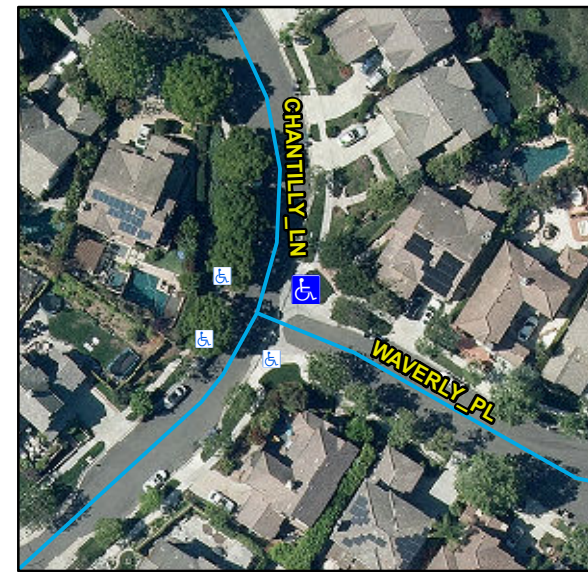
| Compliance | Description | Data | Compliance | Description | Data |
|---|---|---|---|---|---|
| <b>No</b> | Ramp Cross Slope LT (%) | <b>2.2</b> | <b>Yes</b> | Ramp Cross Slope RT (%) | <b>0.3</b> |

**Remove & Replace Curb Ramp With Two New Directional Ramps or Equivalent.**

**R204.3, R304.5.3, STD 1115**

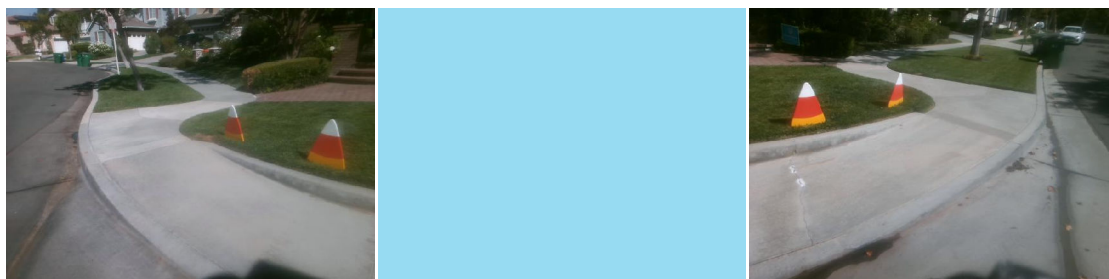
| Compliance | Description | Data | Compliance | Description | Data |
|---|---|---|---|---|---|
| <b>N/A</b> | Ramp Length LT (in) | <b>119</b> | <b>N/A</b> | Ramp Length RT (in) | <b>115</b> |
| <b>Yes</b> | Ramp Width LT (in) | <b>53</b> | <b>Yes</b> | Ramp Width RT (in) | <b>54</b> |
| <b>Yes</b> | Ramp Run Slope LT (%) | <b>4.6</b> | <b>Yes</b> | Ramp Run Slope RT (%) | <b>7.9</b> |
