# Access Compliance Report Public Rights-of-Way (Curb Ramps)

Main Street: BENJAMIN\_DR Cross Street: CHANTILLY\_LN Location: NW

ADA ID: RPRK211020154846 Ramp Type: Type 4 - Parallel Initial Pass/Fail: Fail Overall Compliance: No Severity Score: 45

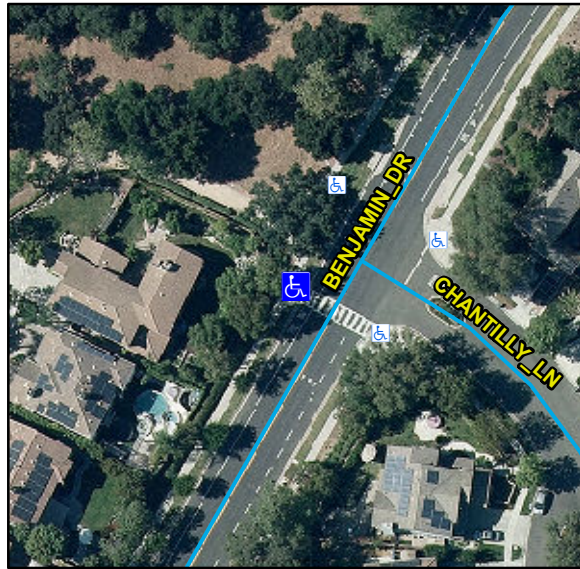
| Compliance | Description | Data | Compliance | Description | Data |
|---|---|---|---|---|---|
| Yes | Ramp Run Slope LT (%) | 0.6 | No | Ramp Run Slope RT (%) | 12.4 |
| No | Ramp Cross Slope LT (%) | 6 | No | Ramp Cross Slope RT (%) | 5 |

Remove & Replace Entire Ramp.

R204.3, R304.5.3, R304.3.2, STD 1115

Total Cost: \$ 2000
