# Access Compliance Report Public Rights-of-Way (Curb Ramps)

| Main Street: <b>CHANTILLY_LN</b> | | Cross Street: <b>BENJAMIN_DR</b> | | Location: <b>S</b> |

| ADA ID: <b>RPRK211020155056</b> | Ramp Type: <b>Type 4 - Parallel</b> | Initial Pass/Fail: <b>Fail</b> | Overall Compliance: <b>No</b> | Severity Score: <b>2</b> |

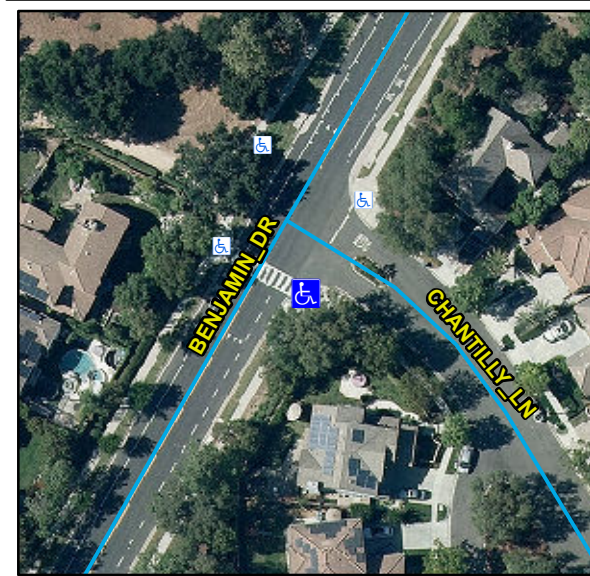
| Compliance | Description | Data | Compliance | Description | Data |
|---|---|---|---|---|---|
| <b>Yes</b> | Ramp Cross Slope LT (%) | <b>1.1</b> | <b>No</b> | Ramp Cross Slope RT (%) | <b>4.3</b> |
| <b>N/A</b> | Gutter Ponding | <b>N/A</b> | <b>No</b> | Curb Slope | <b>20</b> |

**Remove & Replace Curb Ramp With Two New Directional Ramps or Equivalent. Restripe Crosswalk.**
