# Access Compliance Report Public Rights-of-Way (Curb Ramps)

Main Street: BENJAMIN\_DR Cross Street: CHANTILLY\_LN Location: E

ADA ID: RPRK211020155347 Ramp Type: Type 4 - Parallel Initial Pass/Fail: Fail Overall Compliance: No Severity Score: 30

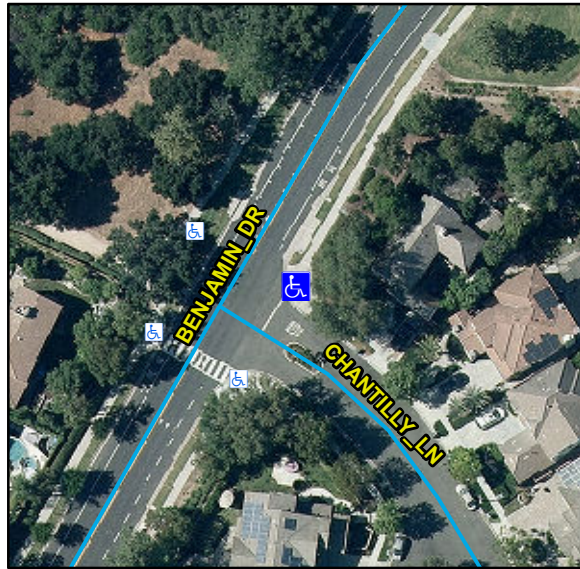
| Compliance | Description | Data | Compliance | Description | Data |
|---|---|---|---|---|---|
| No | Ramp Cross Slope LT (%) | 9.7 | No | Ramp Cross Slope RT (%) | 8.2 |

**Remove & Replace Curb Ramp With Two New Directional Ramps or Equivalent.**

**R204.3, R304.5.3, STD 1115**
