# Access Compliance Report Public Rights-of-Way (Curb Ramps)

| Main Street: BENJAMIN_DR | | Cross Street: BENJAMIN_DR | | Location: | S |
| ADA ID: RPRK211020160246 | Ramp Type: Type 4 - Parallel | Initial Pass/Fail: Pass | Overall Compliance: No | Severity Score: | 40 |

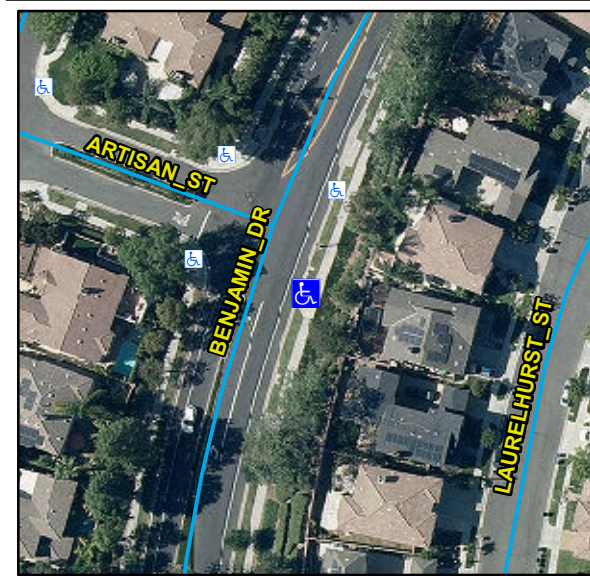
| Compliance | Description | Data | Compliance | Description | Data |
|---|---|---|---|---|---|
| No | Ramp Cross Slope LT (%) | 3.7 | No | Ramp Cross Slope RT (%) | 5.5 |
| N/A | Landing Present | No | No | DWS Provided | No |
| No | Gutter Run Slope (%) | 7.4 | | Road Cross Slope (%) | N/A |

Remove & Replace Entire Ramp. Remove & Replace Gutter.

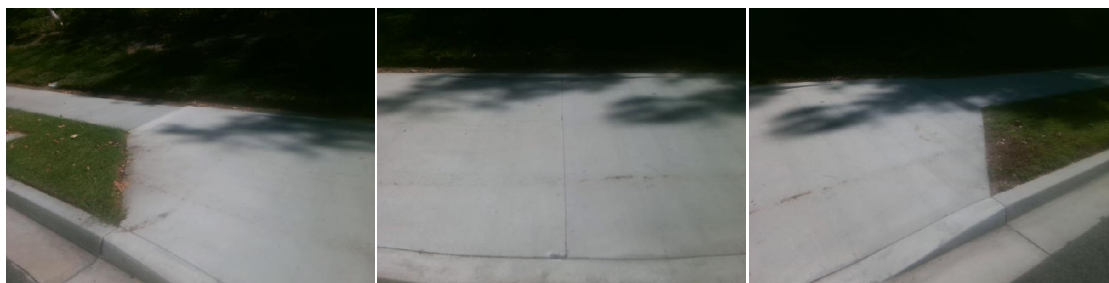
| Compliance | Description | Data | Compliance | Description | Data |
|---|---|---|---|---|---|
| Yes | Overall Surface Condition | Acceptable | | | |
