# Access Compliance Report Public Rights-of-Way (Curb Ramps)

Main Street: BENJAMIN\_DR Cross Street: ARTISAN\_ST Location: W

ADA ID: RPRK211020160634 Ramp Type: Type 1 - Perpendicular Diagonal Initial Pass/Fail: Pass Overall Compliance: No Severity Score: 20

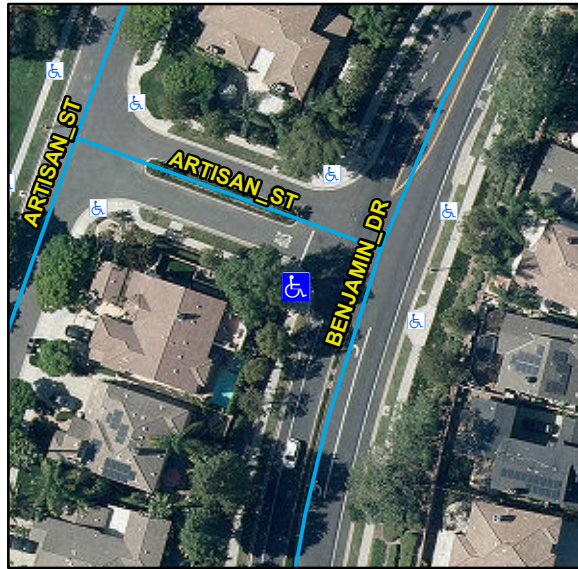
| Compliance | Description | Data | Compliance | Description | Data |
|---|---|---|---|---|---|
| No | Landing Run Slope (%) | 3.8 | N/A | Flare Traversable RT | No |
| No | Landing Cross Slope (%) | 2.4 | No | DWS Provided | No |
| Yes | Gutter Ponding | No | No | Curb Slope | 8.5 |
| No | Gutter Run Slope (%) | 8.2 | | Road Cross Slope (%) | 3.3 |

Remove & Replace Curb Ramp With Two New Directional Ramps or Equivalent. Remove & Replace Gutter.
